Subject Asbestos Containing Materials Survey April 2004
 MDEQ – LOE Contract
 Carter Color Coat Site

**ASBESTOS CONTAINING MATERIALS
NESHAPS SURVEY AND BULK SAMPLING
COLLECTION RESULTS REPORT**

**CARTER COLOR COAT
6051 Hastings Street
Detroit, Michigan**

PROJECT # A-040406

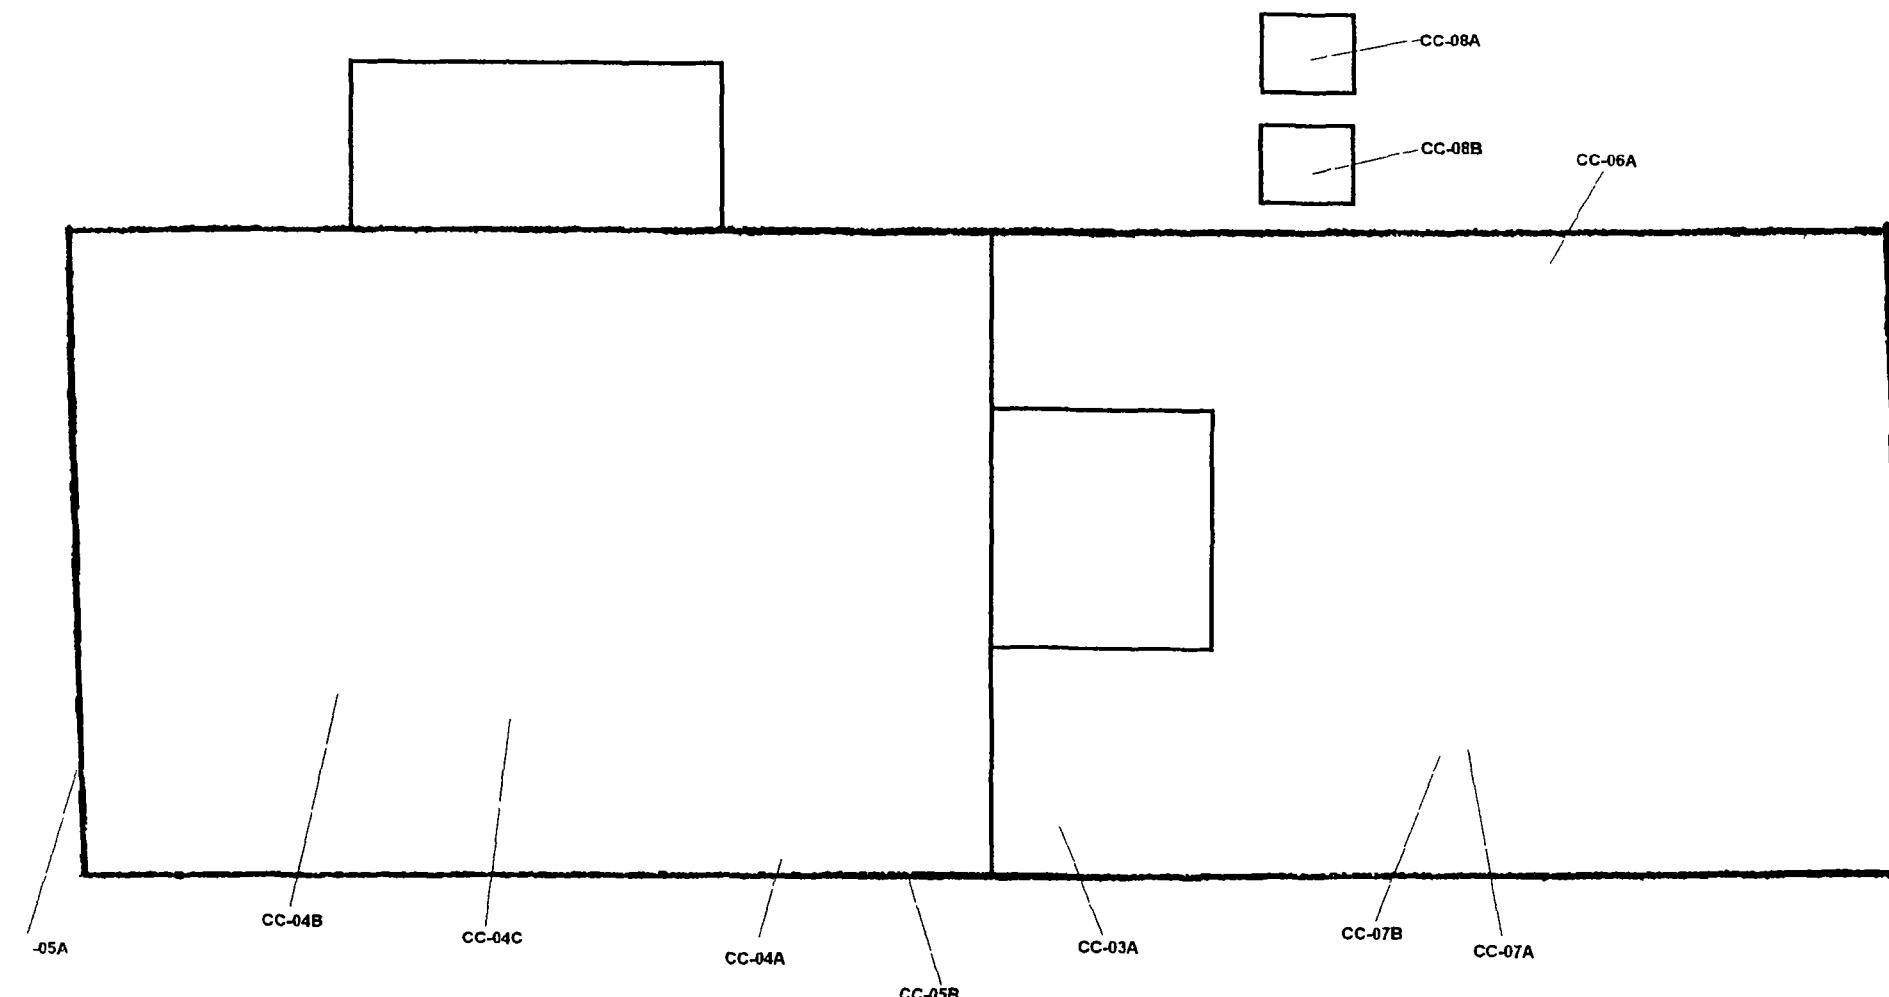
CARTER COLOR COAT
6501 Hastings, Detroit MI
7th Floor

- 7 Material Miscellaneous Material**
Type Raybestos Panels
Sample ID CC 06A
Asbestos Content 60% Chrysotile
Location 7th Floor Main Work Area
Quantity 24 S F
Condition Damaged

- 8 Material Miscellaneous Material**
Type Vibration Expansion Cloth/HVAC Fabric
Sample ID CC 07A CC 07B
Asbestos Content 55 60% Chrysotile
Location 7th Floor Work Area
Quantity 8 S F
Condition Damaged

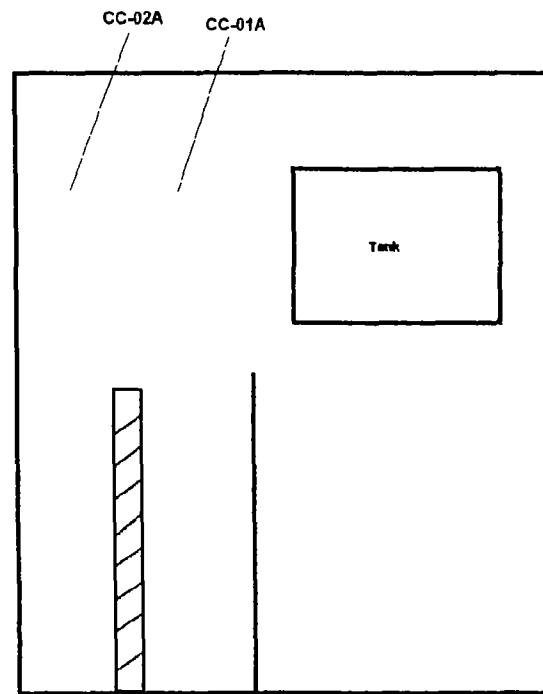
CARTER COLOR COAT
6501 Hastings, Detroit MI
8th Floor Penthouse

- 9 Material Miscellaneous Material**
Type Galbestos Roof Coating
Sample ID CC 08A CC 08B
Asbestos Content 30 40% Chrysotile
Location 8th Floor Roof Tops
Quantity 144 L F
Condition Damaged
